Canton Lake

Dam Safety Project

Informational Brochure

Project Features and Description

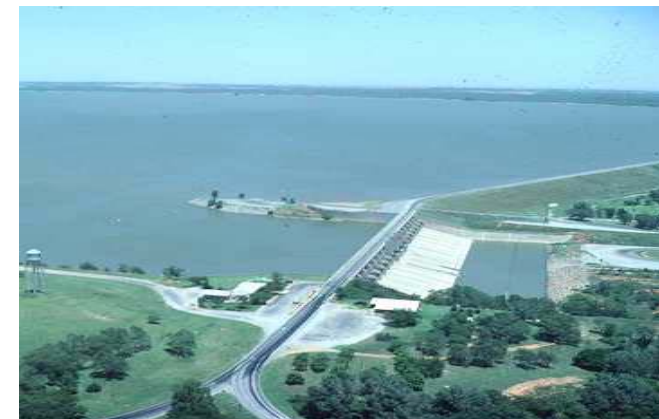
The top corner picture is an aerial photograph of construction progress during the first phase of excavation of the spillway. Vegetation and soil are being removed prior to construction of the spillway channel walls. Soil removed from the channel area is being placed along the downstream toe of the dam. The resulting berm, in conjunction with a new drain system, will control foundation seepage.

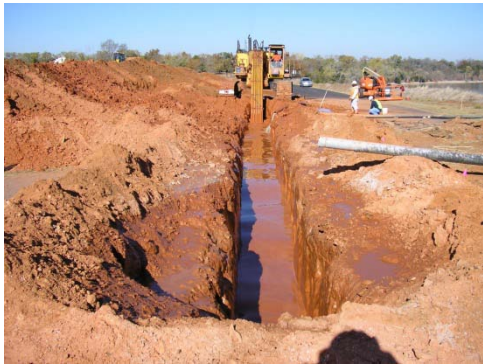
Before any material could be excavated to allow for the new spillway channel, a bentonite-cement slurry cut-off wall was constructed to prevent seepage of water from the lake into the excavation area. The picture below shows construction of the cutoff wall along the lake's edge behind the Canton Overlook.

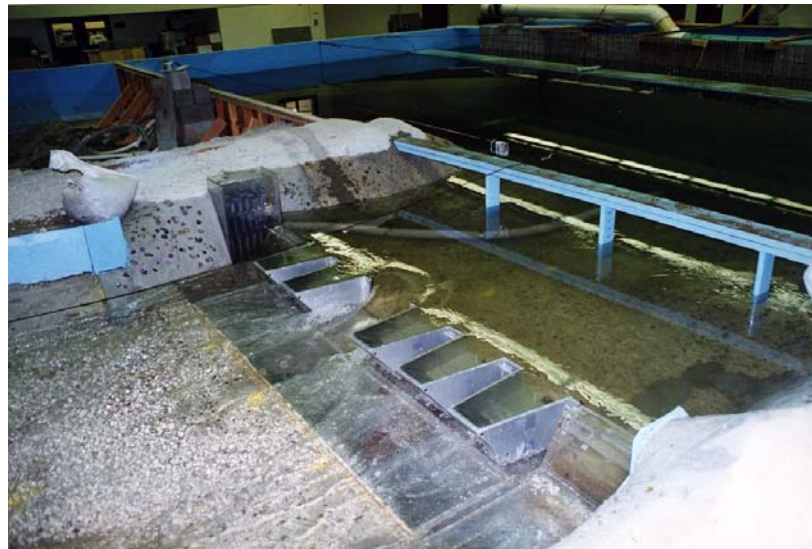
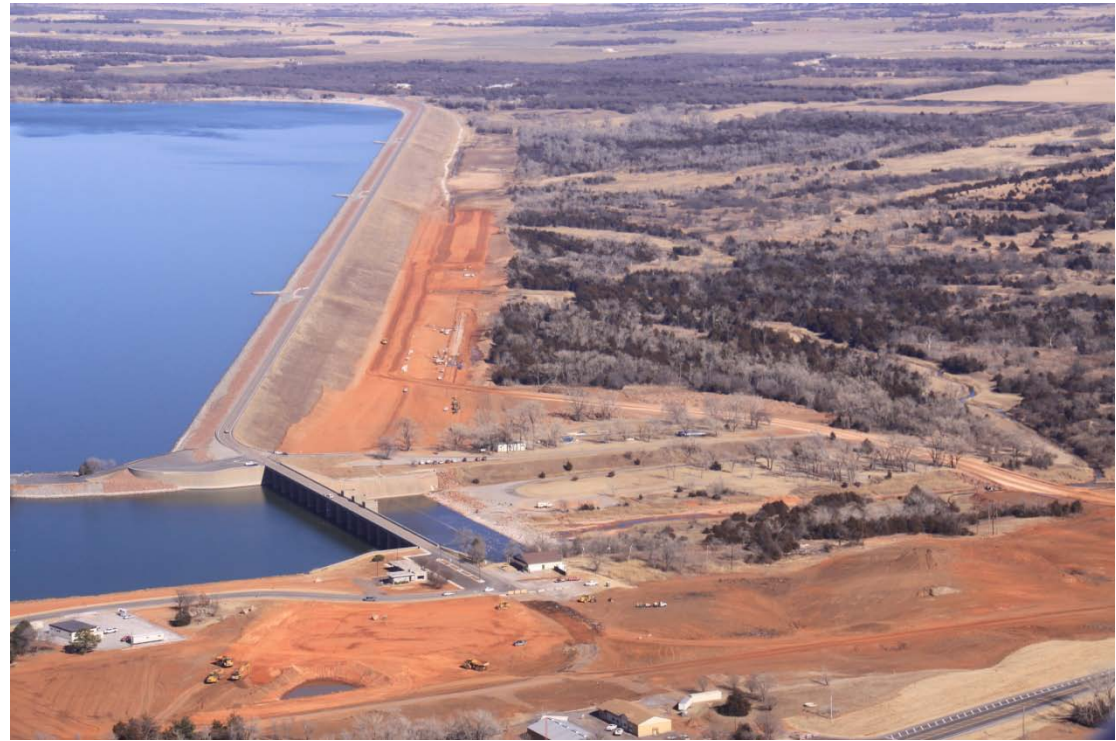
The picture below shows a scale model of the Canton Auxiliary Spillway. The spillway will have fuse gates that tip like giant concrete buckets in a chosen sequence to slow the flow of water through the spillway. This model was built to facilitate the design effort for the project.

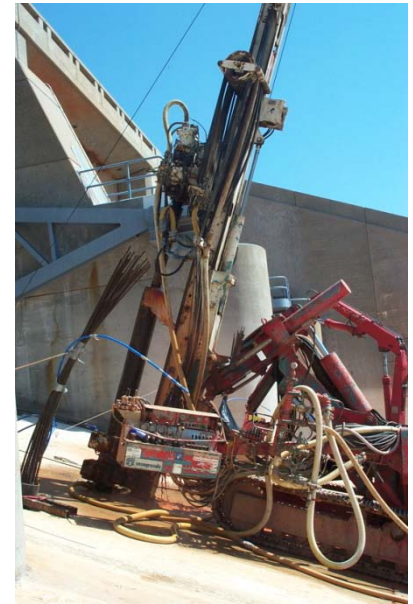
A second deficiency identified was the presence of a weak foundation under the existing spillway. The photo to the right shows the 2006 installation of rock anchors at the existing spillway which corrected this deficiency. These anchors were installed to provide stability to the spillway structure. The anchors were drilled into rock and tensioned.
